#### CITY OF LARKSPUR Staff Report

SUBJECT: UPDATE ON THE CITY'S APPLICATION FOR THE BUILDING FORWARD

INFRASTRUCTURE GRANT AND FORMAL AUTHORIZATION RESOLUTION

# City of Larkspur City Hall

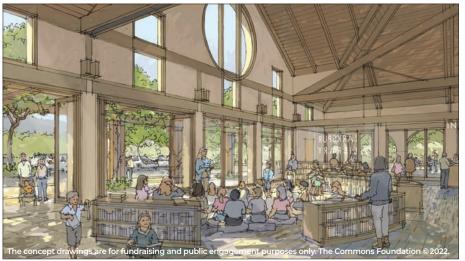
#### **Our New Modern Library**

The liber will result of and outdoor spaces with flexible configurations and moveable bookstacks so it can adapt to the demand at different times of day and provide space for a variety of programs. There will be space and resources for all age groups to enjoy throughout the day and evening.

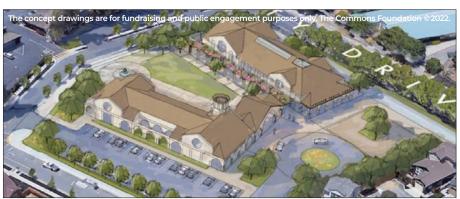
Phases 1-3: A 20,000 sq. ft. Library and Community Center

Today's plan enables future growth. Construction of a core 5,000 sq. ft. library facility could begin as early as 2023. With additional funds, Phase 2 will expand the library and programming space. Phase 3 adds a 10,000 sq. ft. community center. This project will be constructed by the City of Larkspur using a bid-build basis to control costs. For details, visit **thecommonsatlarkspur.org**.
